ICF TECHNOLOGY INCORPORATED

Site Name: Autek Systems Corporation

ENVIRONMENTAL PRIORITIES INITIATIVE PRELIMINARY ASSESSMENT

SITE: Autek Systems Corporation

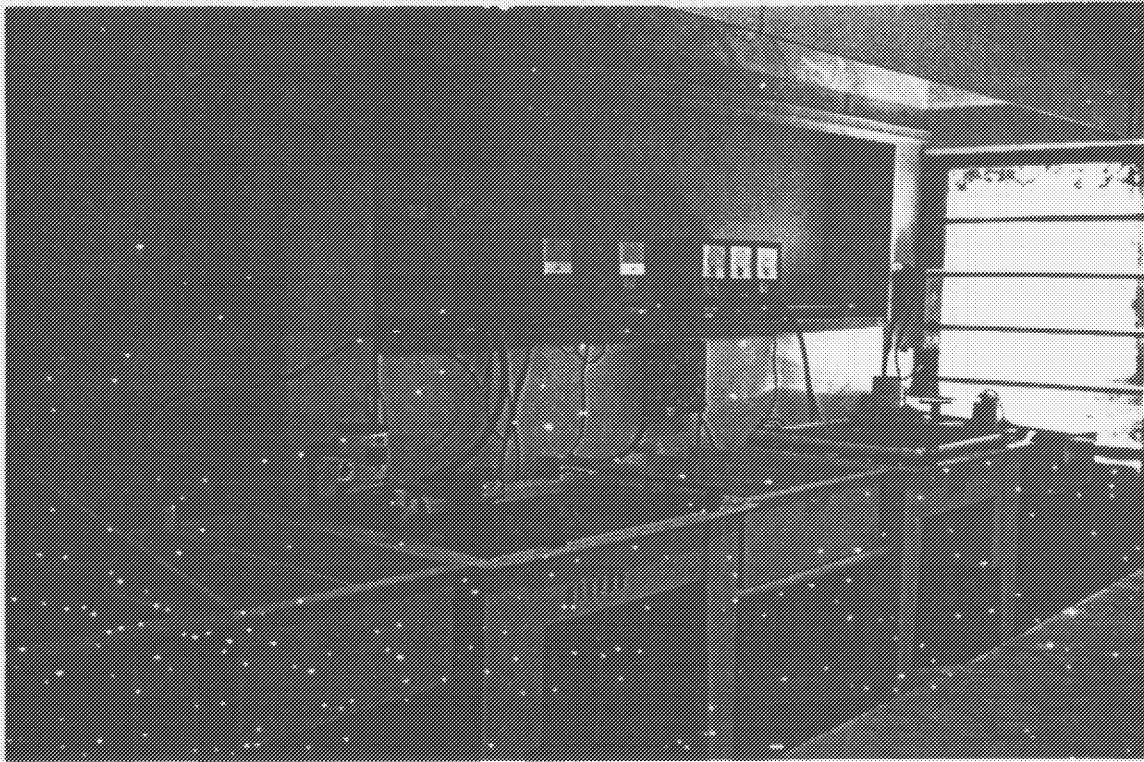
From there we went into the Laboratory and Plating Room. The lab is used for simple analysis of the plating baths to determine the concentrations of copper in the baths, by titrations, and pH (see photo 2). Photo 1 depicts nickel and gold plating baths.

Photo 1: Nickel and Gold Plating Baths in Laboratory / Plating Room

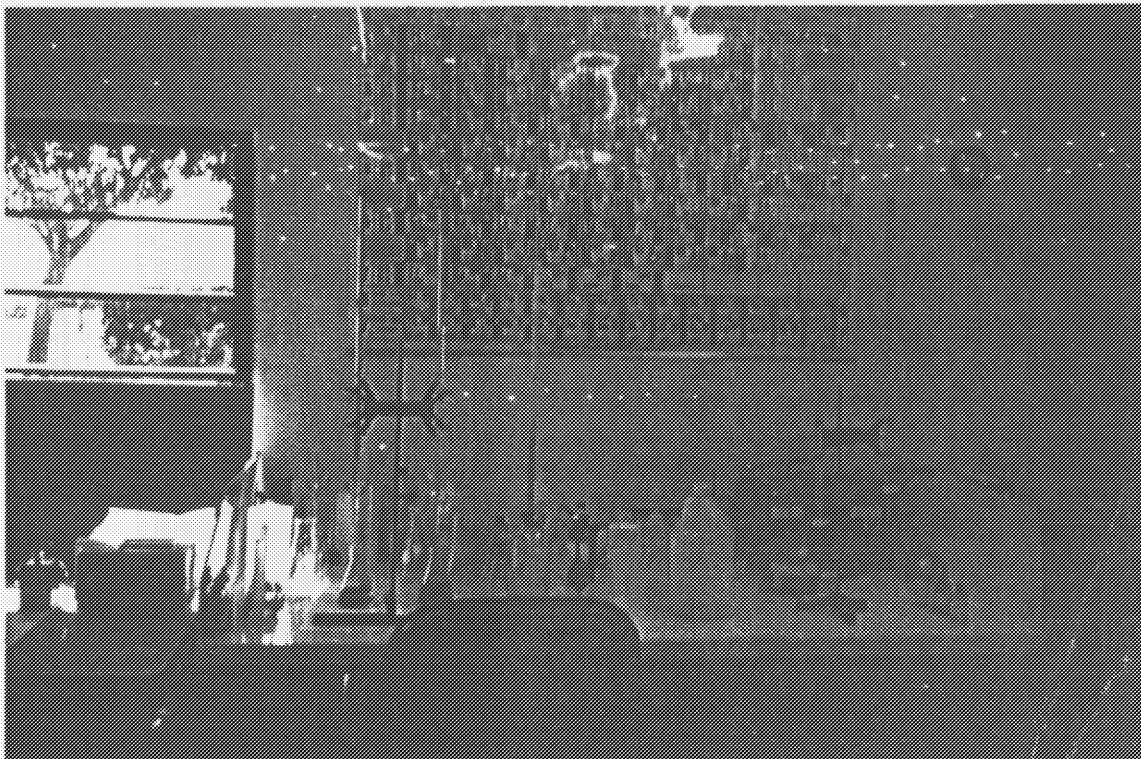
Photo 2: Laboratory area where the concentration of copper in the plating baths is determined by titrations. Also, pH is monitored.

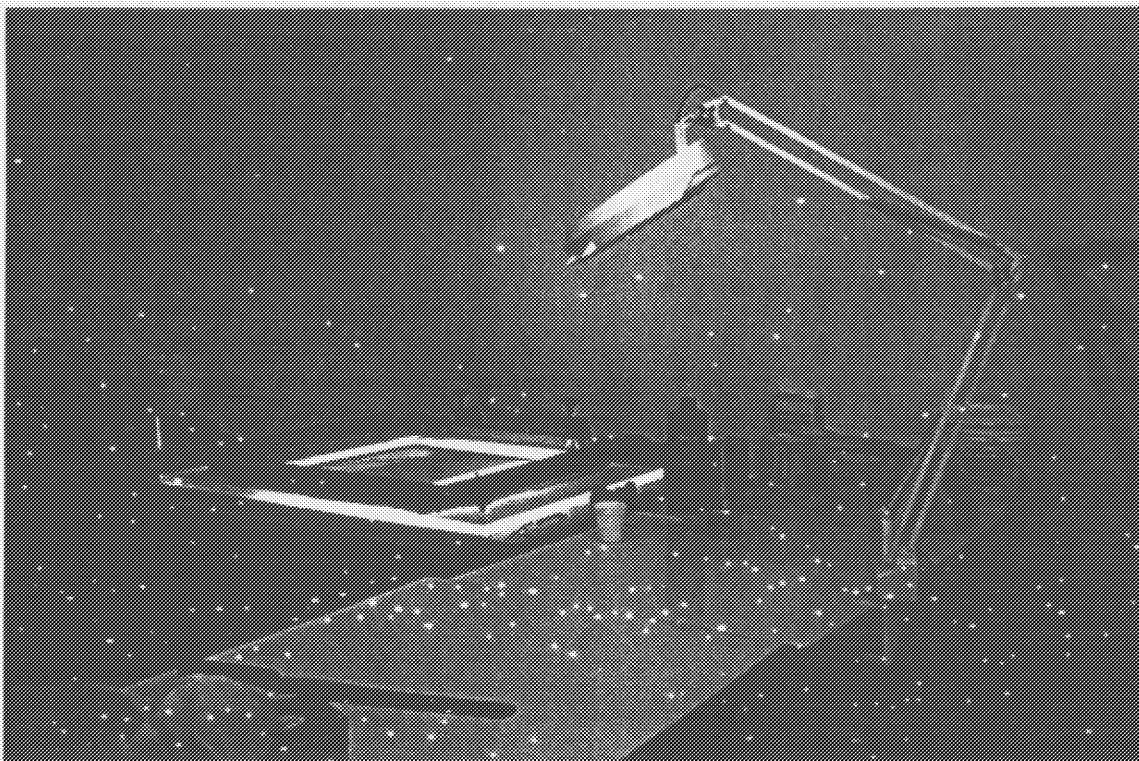
The inspection began with a site tour of the facility with Robert Pereyda and Kim Wishart (see site plan for location). We started in the Inspection and Touch-Up Room. Parts are soldered and inspected and touched-up. A silk screening machine is in the corner (see photo 3) which prints a diagram of the location of

Photo 3: Silk Screening Area where diagrams are printed onto the templates. Some containers of epoxy, various paints, and solvent on table. Containers are products.

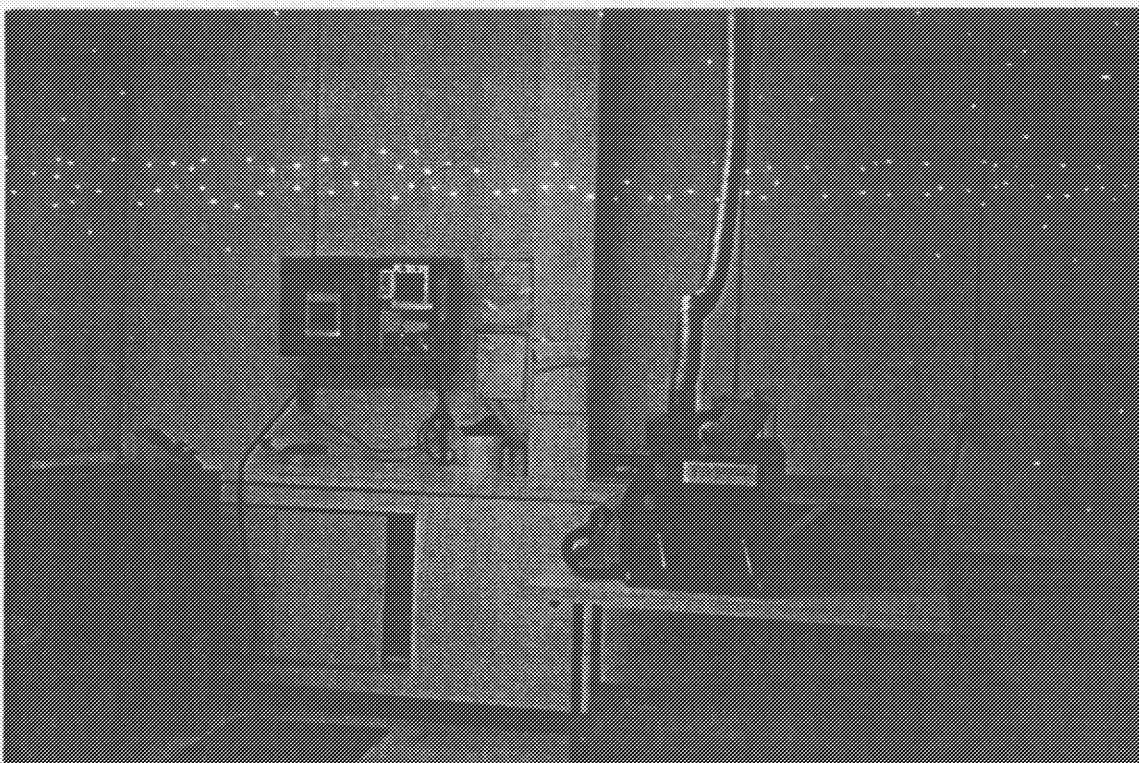
We proceeded to the Dry Film Room where film is copied by reverse imagery. Also, photo tools are produced. Photopolymer fumes from the process are vented through a pipe which leads to the outside (See photo 4).

Photo 4: Dry Film Area: Photopolymer fumes are vented through the silver covered pipe which leads to the outside.

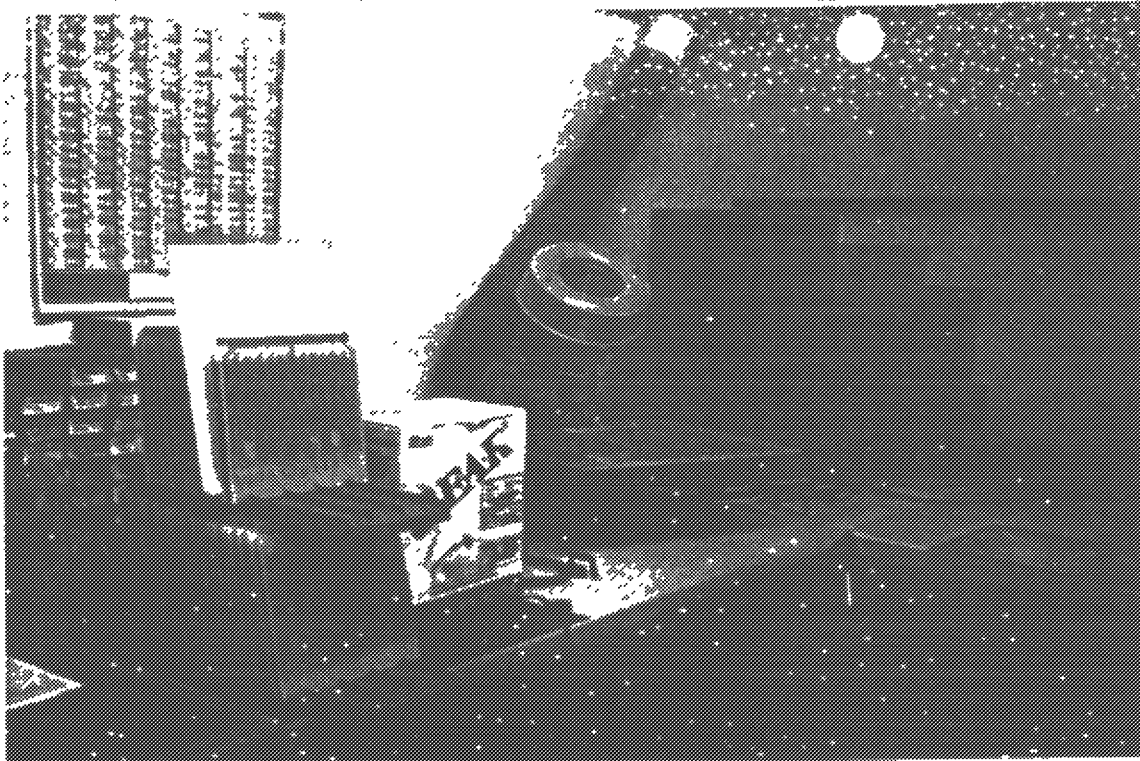
Photo 5:

A Fabrication Room is across from the Dry Film Room. Here, plastic templates are traced and then cut in order for the circuits to be placed in the spaces. Fiberglass dust is the main health concern in this area (see photo 5).

Fabrication Room where templates are cut so circuits can be fitted into the slots. Fiberglass dust is the main health concern during operations.
